Department of Neighborhood Services Façade Report Application

Address of Building: 901 North 9th Street TaxKey 3910103110

Date of the Report: November 30th, 2016 Occupancy of Building: Assembly - Courthouse

Name: Todd A. Gorrell, R.A. Firm Name: Klein and Hoffman, Inc.

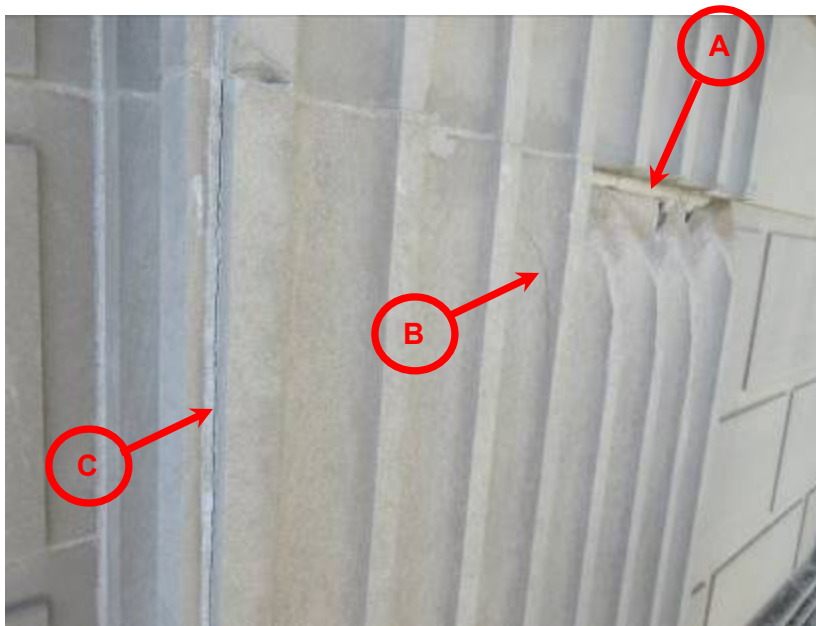
1. Spalled sections of stonework had been previously removed at quite a few locations (see Photo No. 1). New spalls were removed at numerous locations during our inspections.

Photo No. 1 (A) Previously removed spall and (B) new cracks in stone unit on Drop #18b. Note (C) separation in mortar joint.

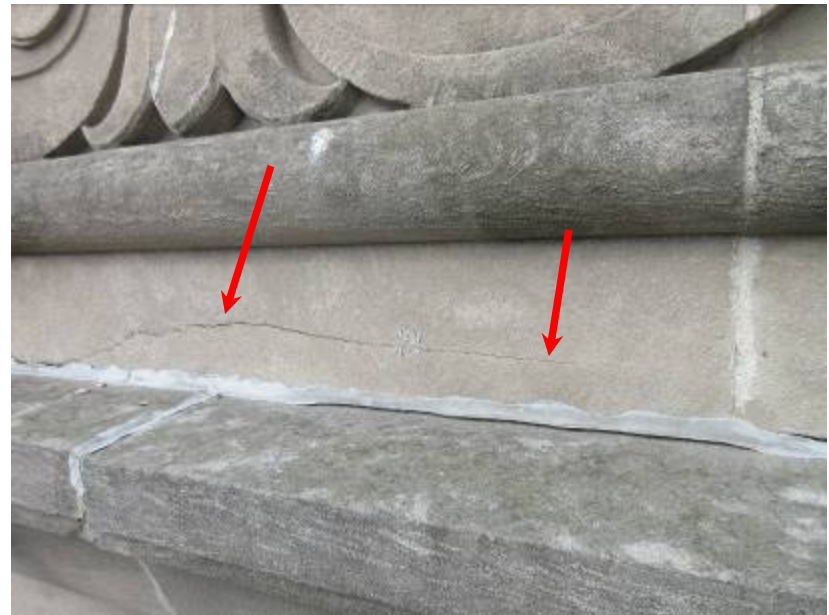
- a. Approximately eight (8) small spalls were observed at the high, eighth floor, cornice. The spalls appeared random, and did not seem to suggest systemic deterioration of concealed conditions (see Photo No. 2).

Photo No. 2 Spalls at the eighth floor cornice. Spall was sealed.

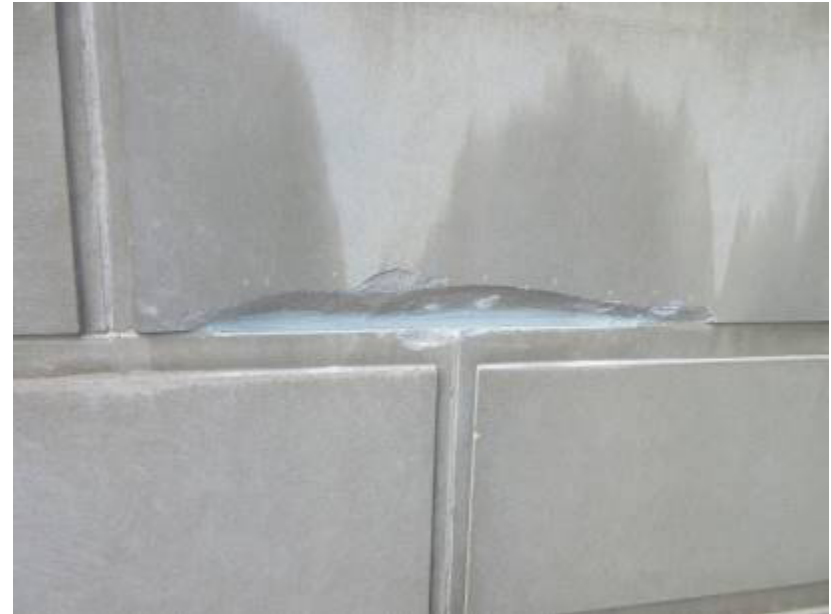
- c. Approximately twenty four (24) small to medium sized spalls were observed at the ashlar base of the building – floors one through three. These spalls were concentrated below the cornice at the base of the colonnade where open wash joints were common, suggesting that water infiltration through these joints, into the masonry below, is causing corrosion of embedded metal framing and anchorages (see Photo No. 4).

Photo No. 4 Spall removed and open joint sealed at the ashlar base of the building at drop no. 15.

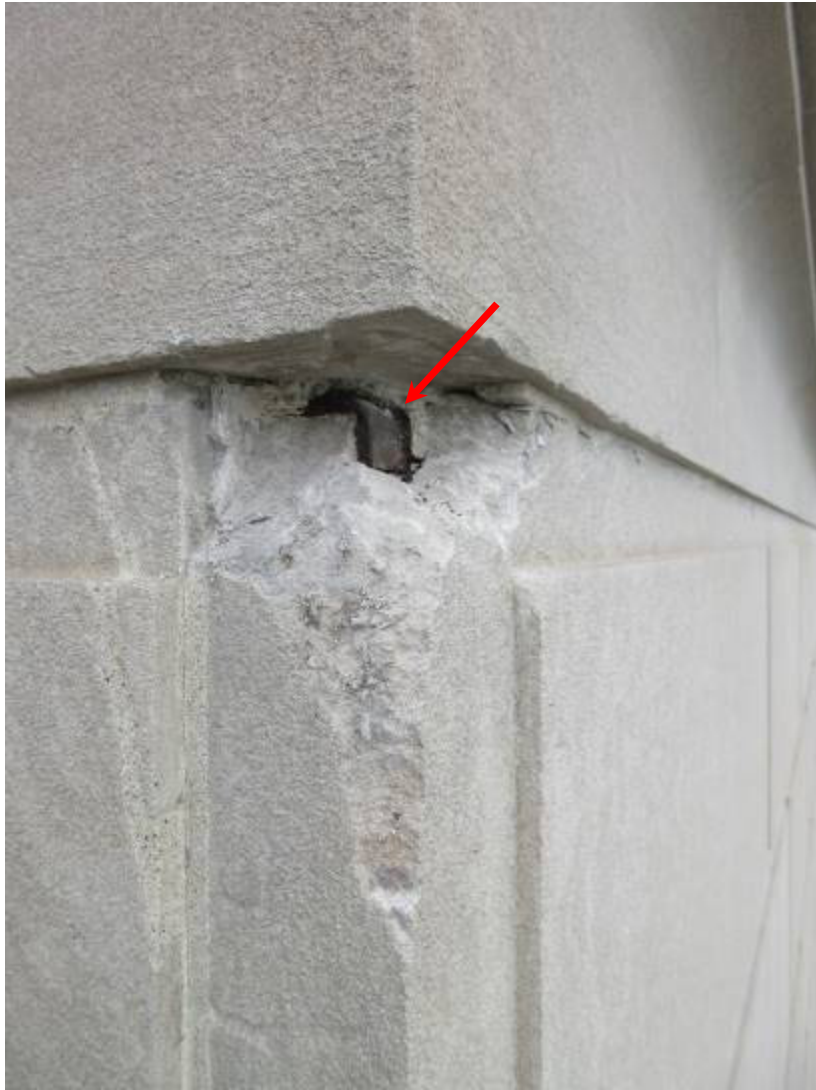
- d. Several spalls were observed at the southeast corner below the eighth floor cornice (refer to drop sheet from drop nos. 31-35). Corroded metal cramp anchors were observed after removal of the loose spalls. Building corners, in general, are exposed to the worst weathering, and are also the most susceptible to open joints cause by building movement. These factors, combined with open wash joints at the eighth floor cornice have likely contributed to water infiltration into the masonry and corrosion of embedded metal anchorages as well as freeze/thaw damage (see Photo No. 5).

Photo No. 5 View of corroded cramp tie after removal of spall at southeast corner below eighth floor cornice. Cramp and open joints were sealed.

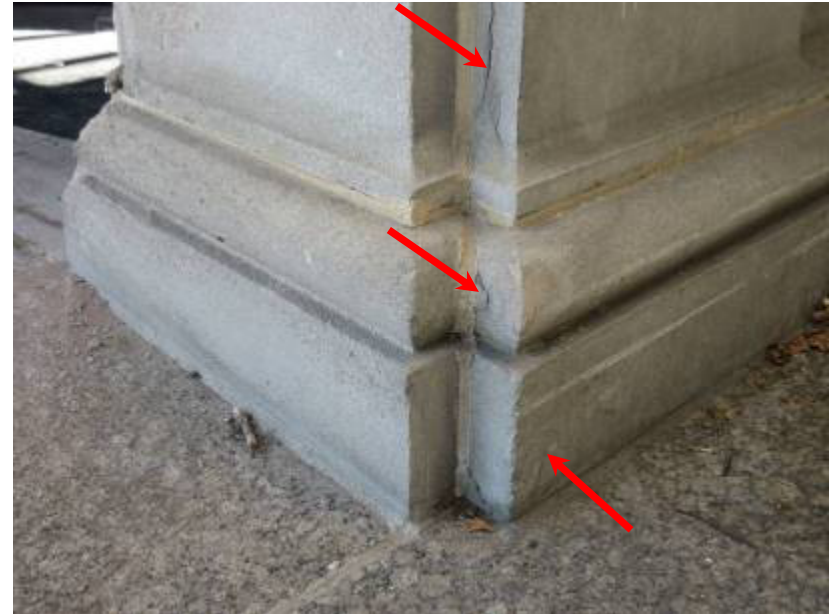
- e. Spalls were frequently observed at the stone surrounding entrances. Such spalls appear to be due to exposure to high traffic, de-icing salts, and general weathering (see Photo No. 6).

Photo No. 6 Cracking/spalling visible at pier flanking the revolving door entrance at the east elevation.

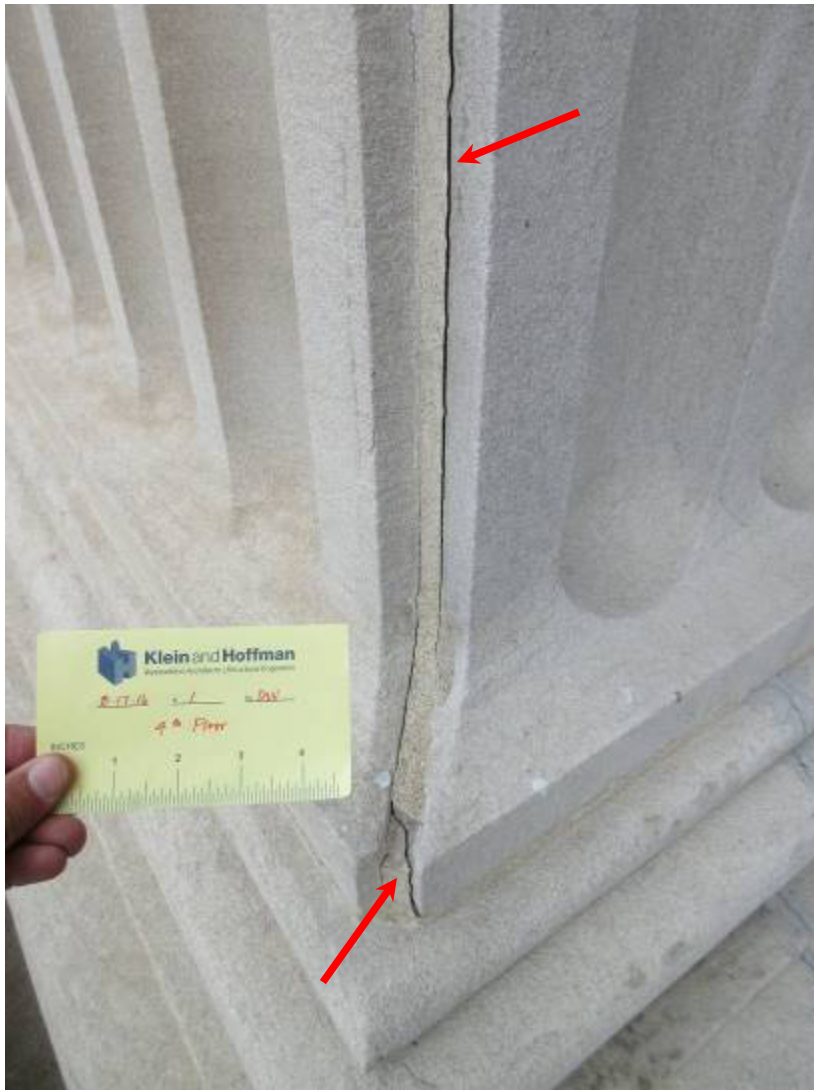
2. Separations in mortar joints, indicating ongoing movement of the stone units, is generally caused by water trapped within the walls during freeze/thaw cycles or by ongoing corrosion of embedded steel components within the walls. This condition occurs at random locations throughout the facades (see Photo Nos. 7 and 8).

Photo No. 7 Separation in mortar joint caused by ongoing movement of the stone units.

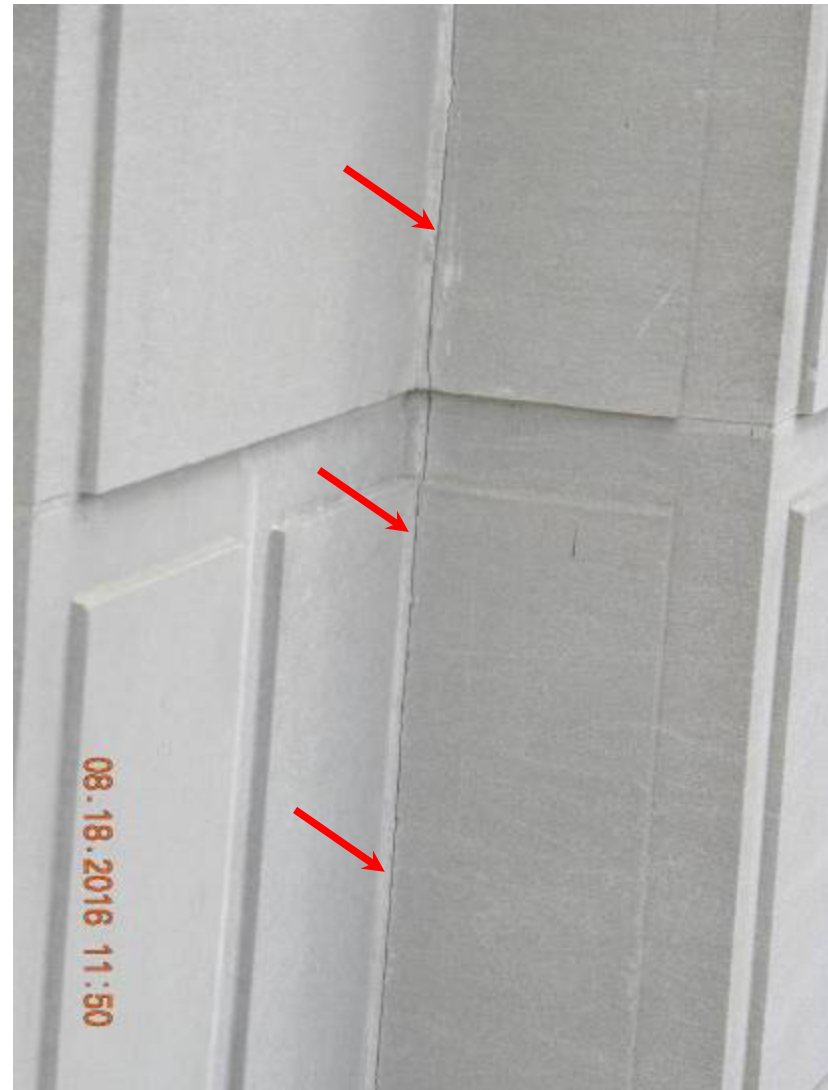
Photo No. 8 Separation in mortar joint caused by ongoing movement of the stone units.

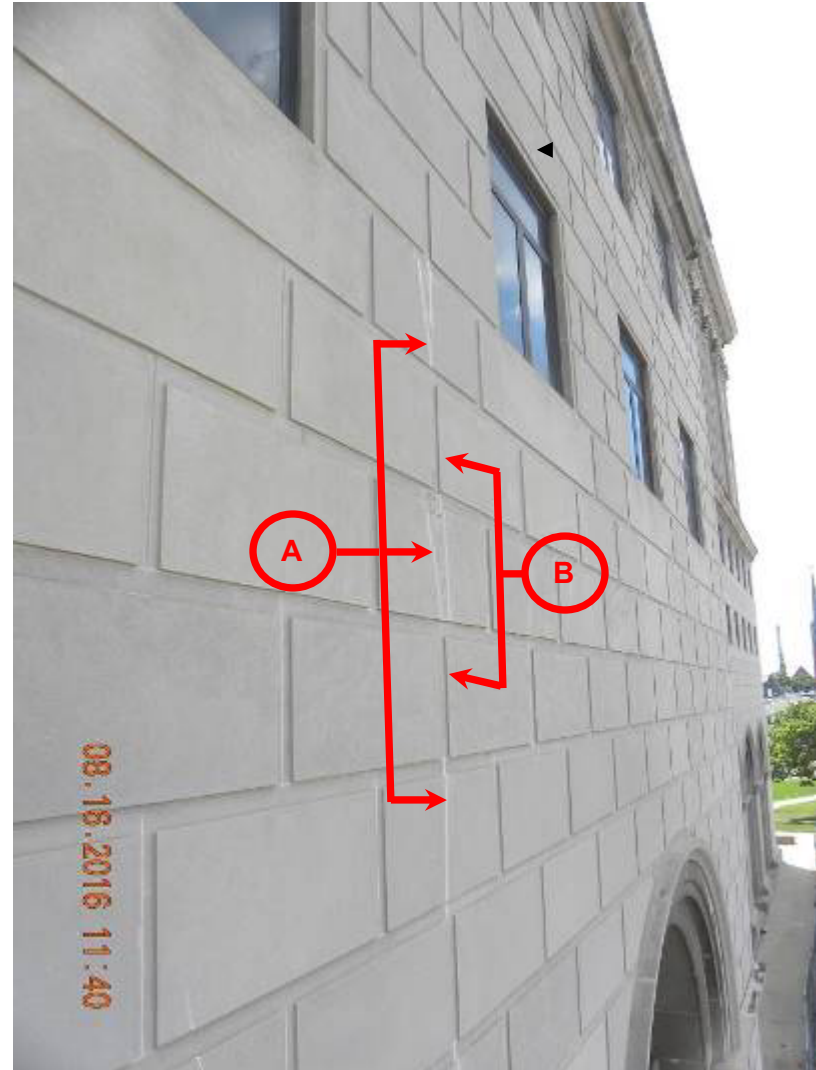
3. Continuous cracking, generally vertically, in stone units was found at several locations and indicates distress within the wall at those areas (see Photo Nos. 12 and 13).

Photo No. 12 Continuous cracks (A) and separations in vertical mortar joints between cracked units (B) indicate ongoing distress within the walls.

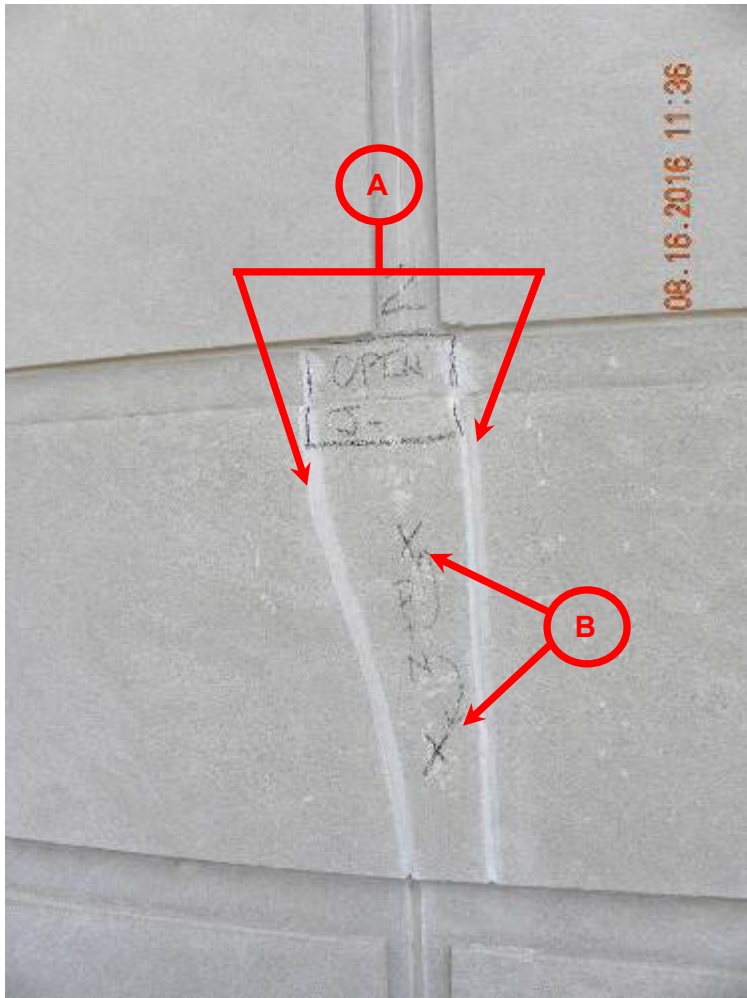
Photo No. 13 Previously patched cracks, with patch material that does not match the stonework, have started to separate (A). The loose portion of that patched stone was designated to be pinned with stainless steel pins as temporary stabilization (B).

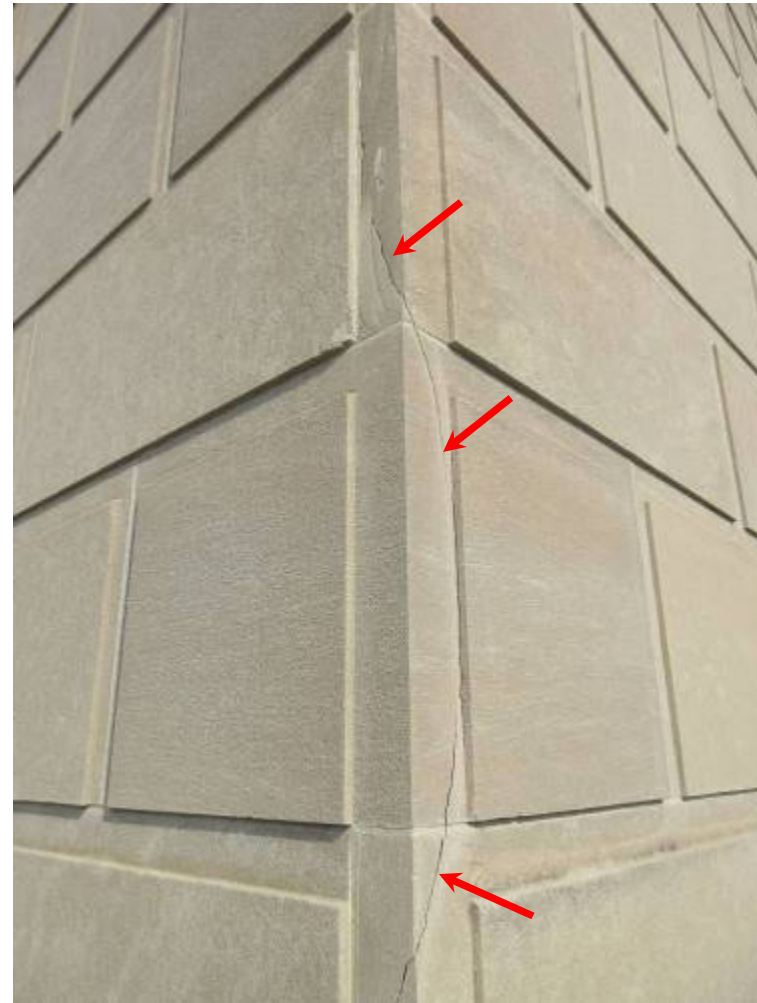
- a. At the northeast and southeast corners of the seventh through eighth floors, numerous cracked stones were observed. Cracking also extended into the brickwork below the stone. The cracking may be due to corrosion of corner steel columns, and the subsequent transfer of expansive forces into the masonry (see Photo Nos. 14 and 15).

Photo No. 14 Cracked stones at the seventh floor at the southeast corner.

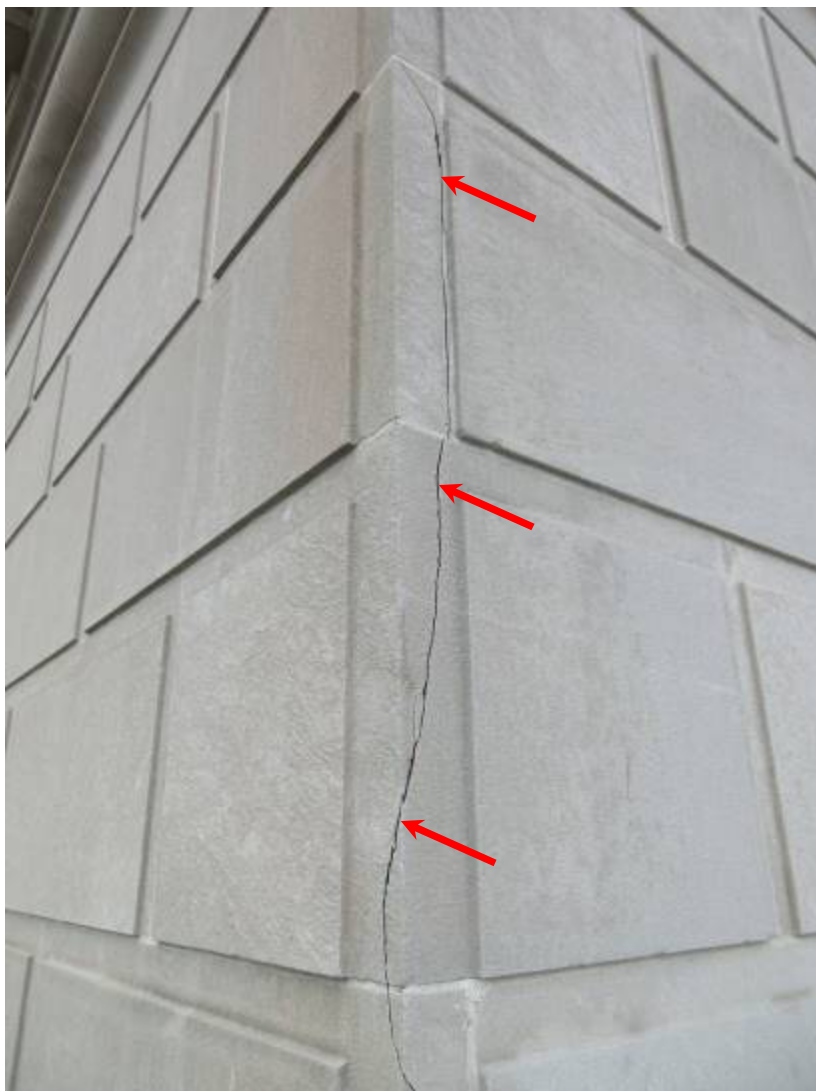
Photo No. 15 Cracked stones at the eighth floor at the northeast corner.

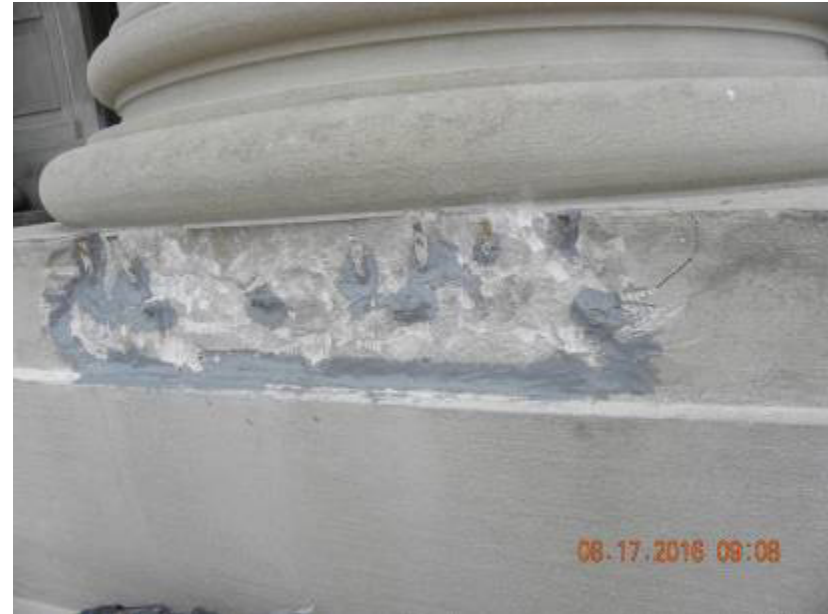
4. Hundreds of cracked stones throughout the facades had been previously patched or repaired. Poorly matching patch material was frequently observed and no supplemental anchors were found to have been installed in the patch repairs which were removed during inspections. Defective patches were removed at numerous locations (see Photo Nos. 17 and 18).

Photo No. 18 Removal of defective patch material from previous photo and sealing of openings. No supplemental reinforcing was found in the previous patches removed during our inspections.

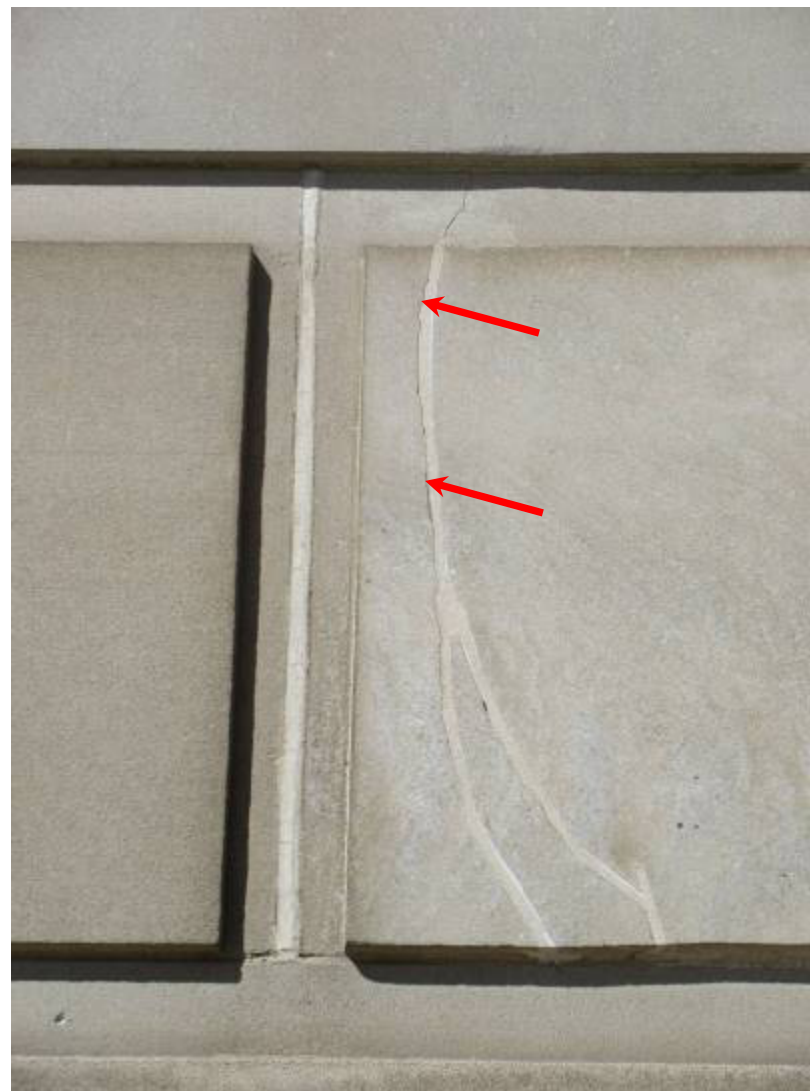
5. Crack repairs were generally in fair to good condition. Isolated locations where new cracks had developed at previously repaired cracks were observed (see Photo Nos. 19 and 20).

Photo No. 20 New cracks developing at previously repaired crack.

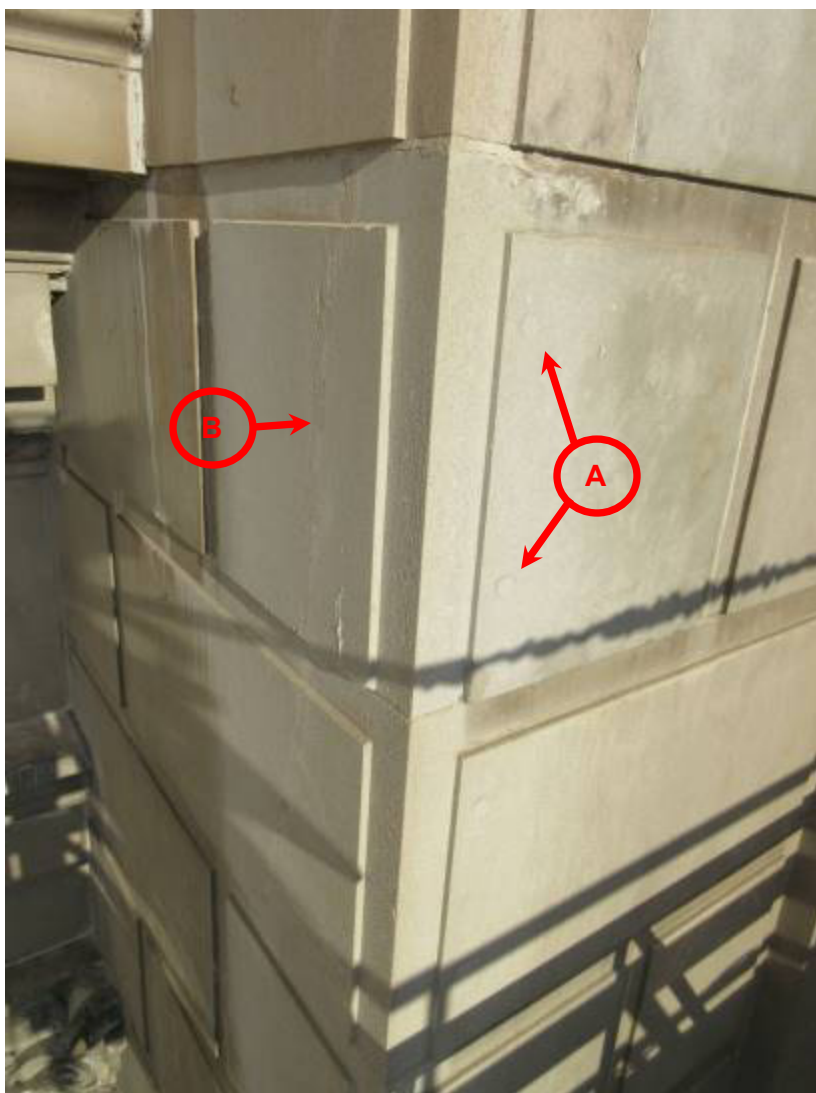
- a. Previous pin and epoxy repairs of cracked stones were observed at the north and south corners of the central portion of the east elevation (refer to drop sheets from drop nos. 10 and 13a), and at various locations along the sixth floor cornice. The repairs appeared to be in good condition (see Photo Nos. 21 and 22).

Photo No. 21 Previous pin and epoxy repairs at drop no. 10. Pins (A) located on the east face of the wall, epoxied crack (B) located on the south face of the wall.

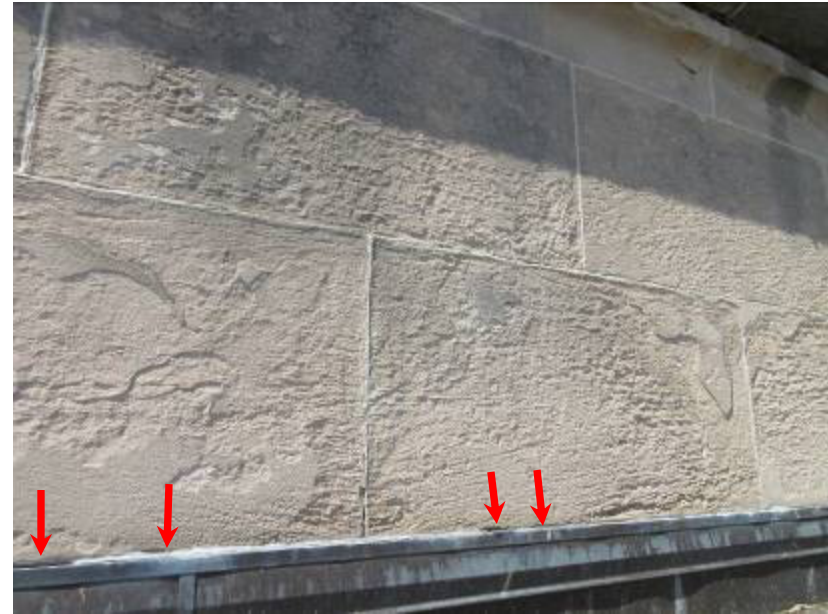
7. Previous limestone cleaning efforts with harsh acidic cleaning materials have resulted in damage to the outer finished face of the stonework at numerous locations (see Photo No. 24). Rust staining of large portions of the stonework on the east elevation is the result of cleaning with harsh chemicals which reacted with the iron deposits in the stone. The surface of such stones was generally stable, however a small amount of flaking and delaminating surface was removed where observed (see Photo No. 25).

Photo No. 24 Pitted stone surfaces possibly caused by harsh acids allowed to dwell for extended periods on the façades during previous cleaning efforts. Note large voids in the sealant joints at the top of the roof counterflashing.

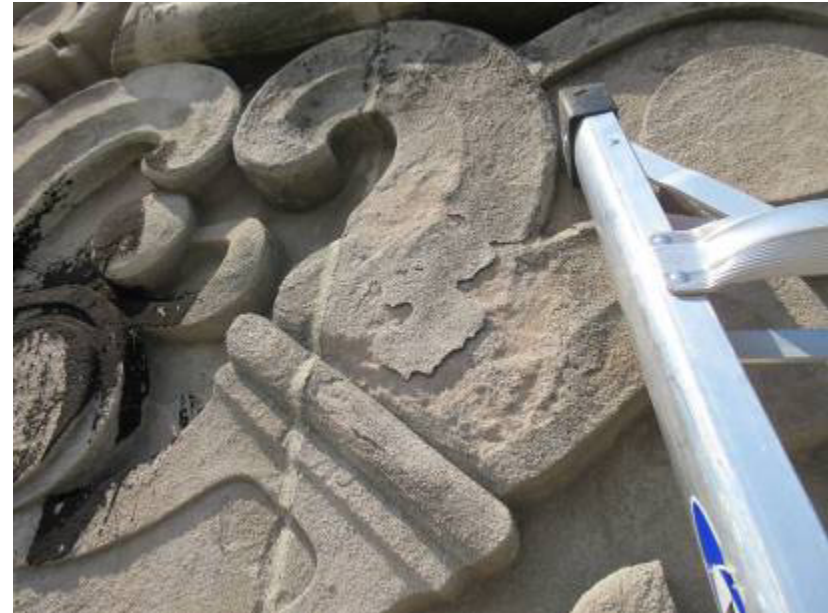
8. Some areas of surface erosion were observed at the south side of the east elevation. This erosion appears to be due to localized severe weathering. Such surfaces were generally stable, but loose material was removed where observed (see Photo No. 26).

Photo No. 26 Weathered stone surface with minor delamination at the eighth floor cornice of the east elevation. Surface delaminations were removed where observed.

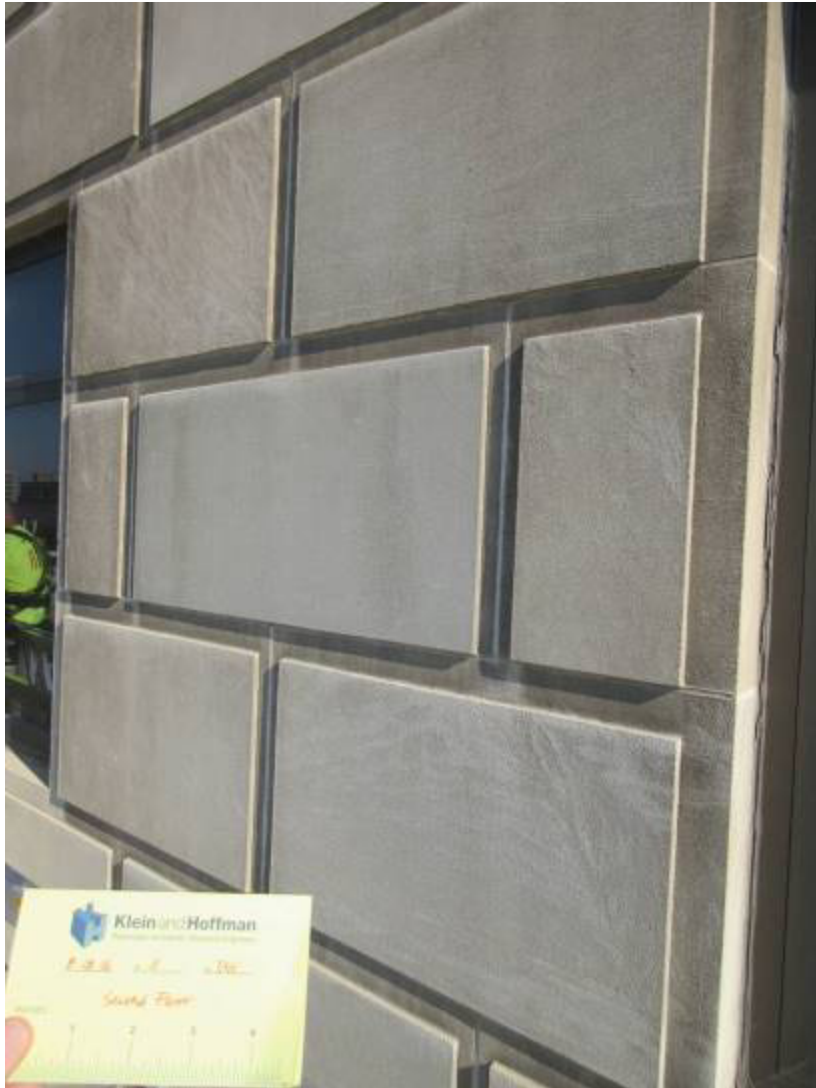
9. The mortar joints in the stonework on the façades are generally in fair condition (see Photo No. 27).
 - a. Isolated deteriorated mortar joints were observed throughout the façades. Failed mortar joints were frequently observed at stacked joints at the corners of pilasters, corners of the ground level arcade, and projecting masonry (see Photo Nos. 28, 29, and 30).

Photo No. 27 Showing typical condition of ashlar limestone and mortar joints.

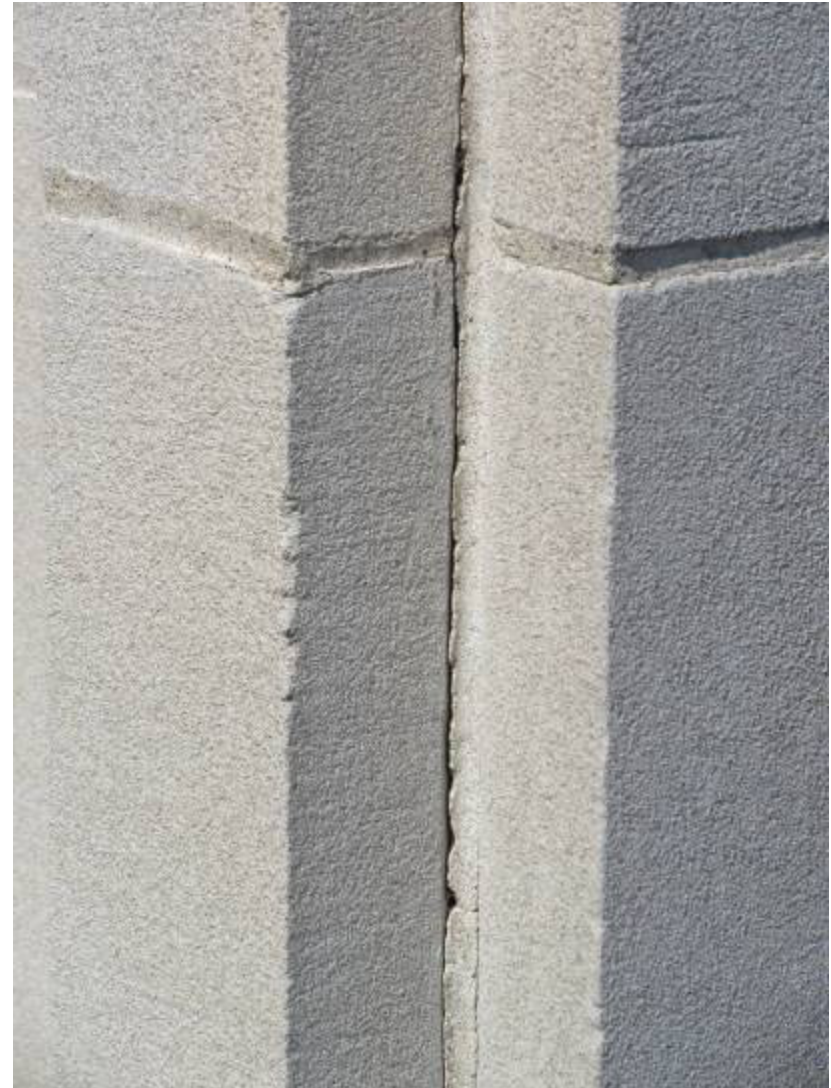
Photo No. 28 Typical deteriorated mortar joint at corner of pilaster.

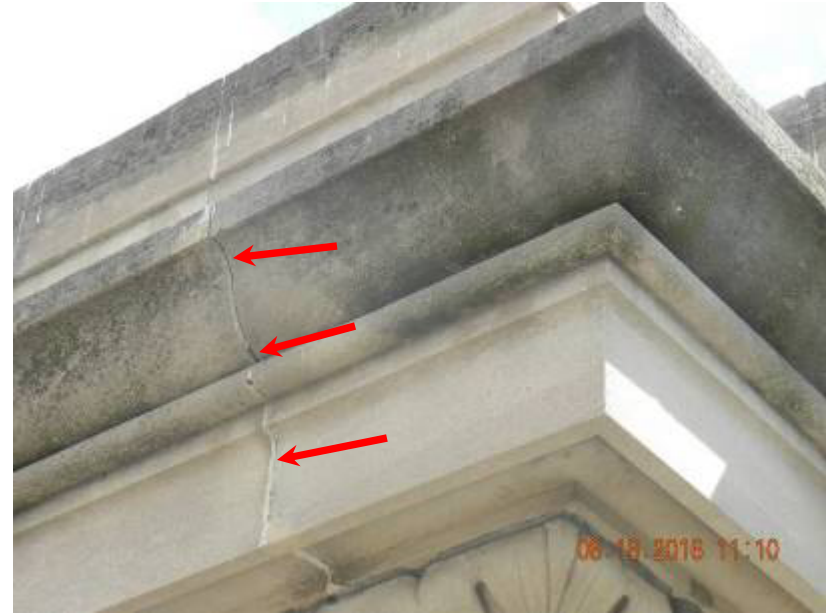
Photo No. 30 Mortar joint at upper cornice at south end of west elevation in poor condition with open voids and separations.

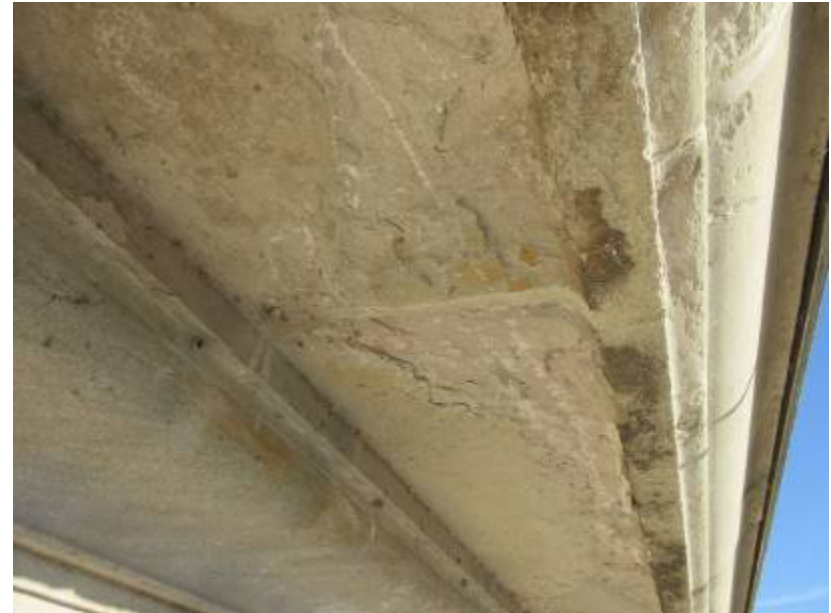
10. At the south side of the east elevation, deterioration of the stone surface at the underside of the sixth floor cornice was observed. The deterioration appeared to be superficial, and is likely related to past water infiltration through the sheet metal gutter directly above. Loose surface material was removed where observed (see Photo No. 32).

Photo No. 32 Deterioration of the stone surface at the underside of sixth floor cornice.

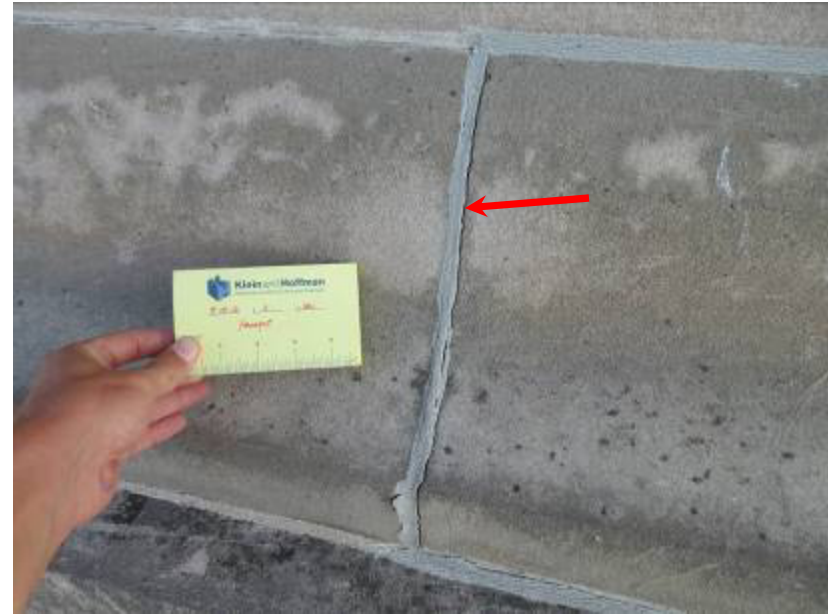
12. Severely deteriorated and/or failed sealant on wash (upward facing) joints were found throughout the façades (see Photo Nos. 34 and 35). Water freely entering into the building's façades will promote advanced deterioration of the façade components. Water trapped in the walls during freeze/thaw cycles will generate expansive forces causing spalling and cracking of masonry units (see Photo Nos. 36 and 37). Water entering the walls will also promote corrosion of embedded steel components such as lateral ties, anchors, and support angles and possibly the structural steel framework. The corrosion of embedded steel components within the walls generate expansive forces to the exterior masonry resulting in spalling, cracking, and displacement (see Photo Nos. 38 and 39).

Photo No. 34 Open sealant joint at base of parapet wall on Drop #3.

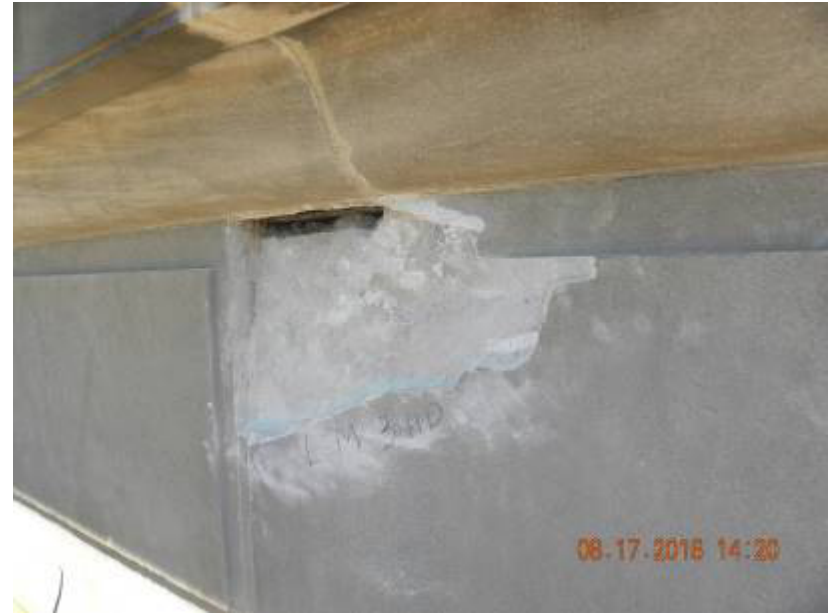
Photo No. 36 Fairly large, loose spall removed directly below 4th floor wash coursing, L – M Façade, west elevation.

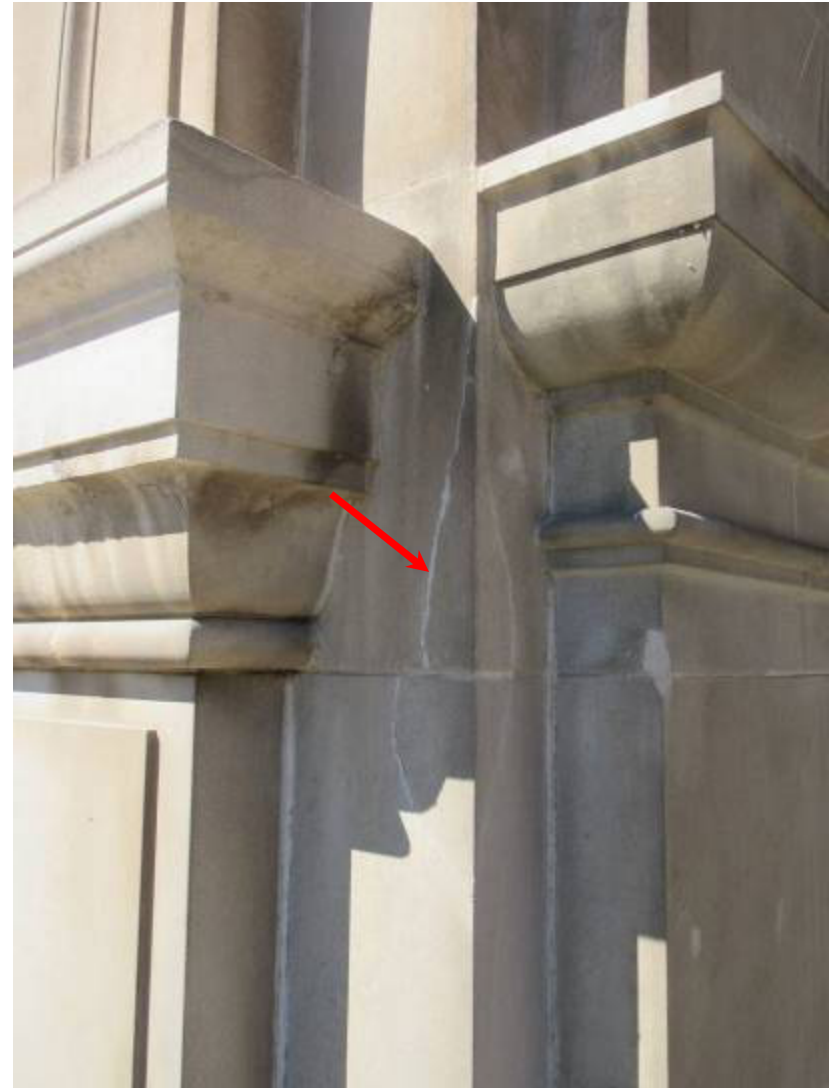
13. Small epoxy repairs were observed at many locations throughout the façades. The repairs were generally in good condition (see Photo No. 40).
14. Stone Dutchman repairs were observed at many locations throughout the façades. The repairs were generally in good condition (see Photo No. 41).

Photo No. 40 View of epoxy repair at east main entrance at drop no. 12

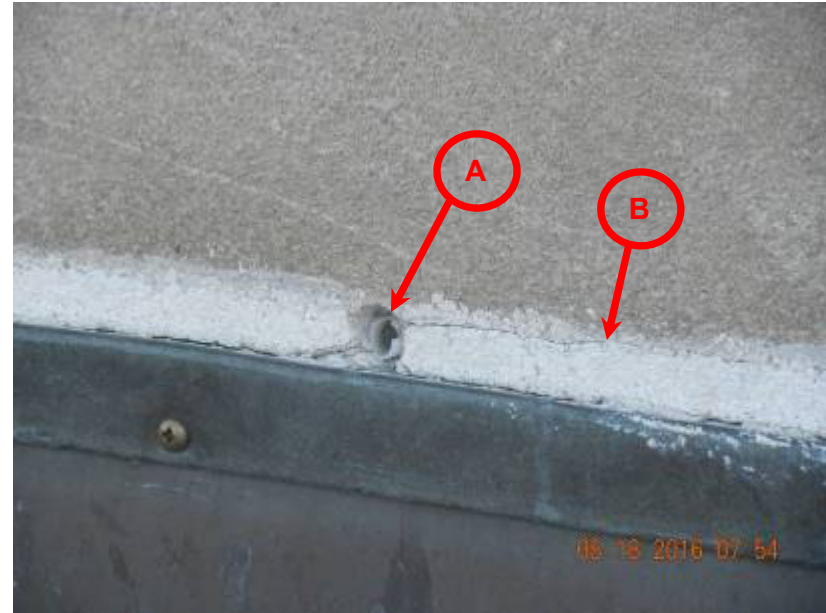
2. Back-pitched weep holes installed directly over the back side of the gutter occur at the south end of the west elevation (see Photo No. 44). Ponding water in the gutter below indicates a clogged drain in the area (see Photo No. 45). Water overflowing the gutter during heavy rains will flow into the walls through the back-pitched weep holes prompting accelerated deterioration of the façades below.

Photo No. 44 (A) Back-pitched weep hole above gutter at 6th floor, N – P Façades, west elevation. Note deteriorated sealant joint (B).

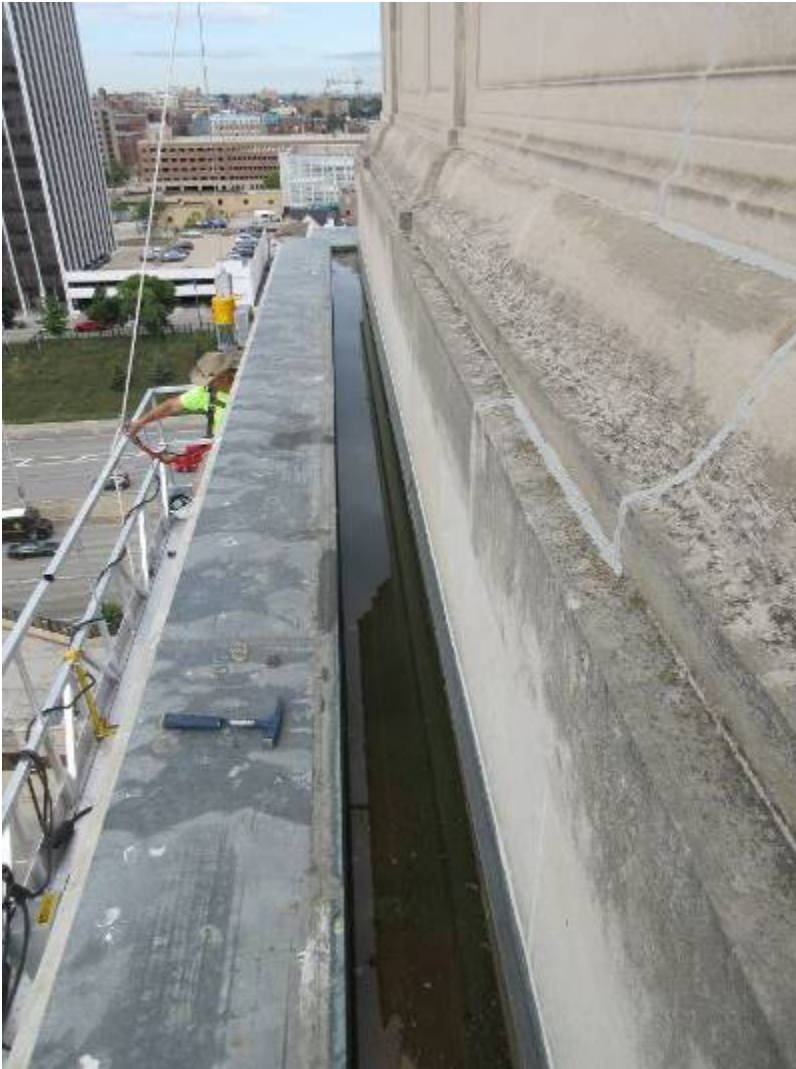
Photo No. 45 Ponding water in gutter at west end of south elevation. Extends around the corner on the west elevation.

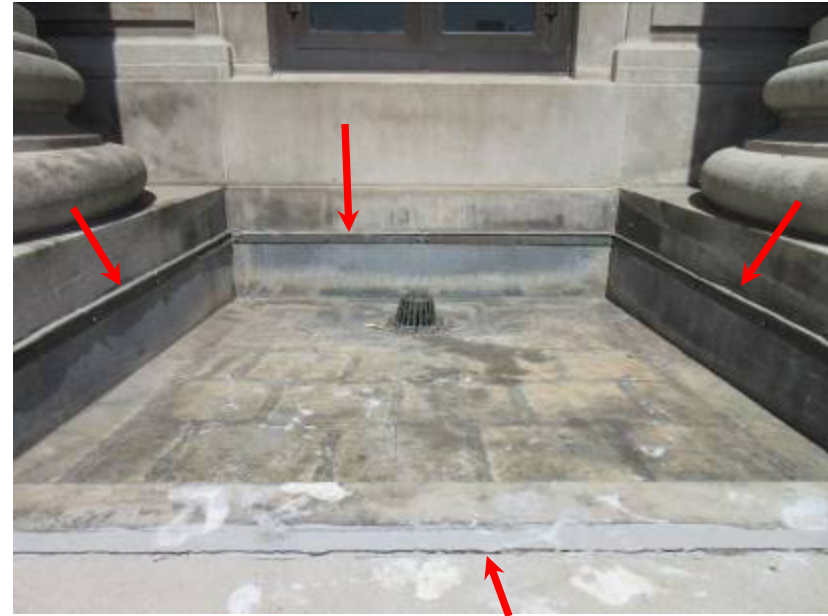
Photo No. 46 Open and deteriorated sealant joints surrounding the metal collector pans at Drop #2 at the 4th floor.

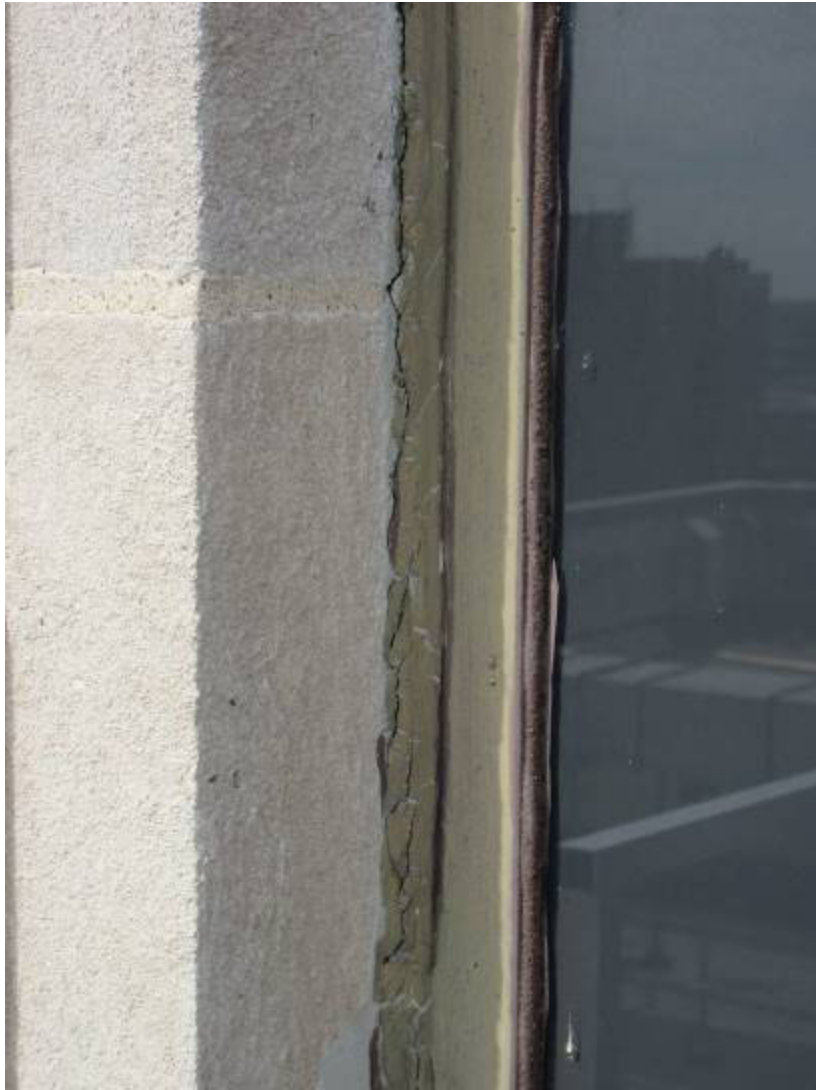
Photo No. 47 Showing typical failed window perimeter sealant joint.

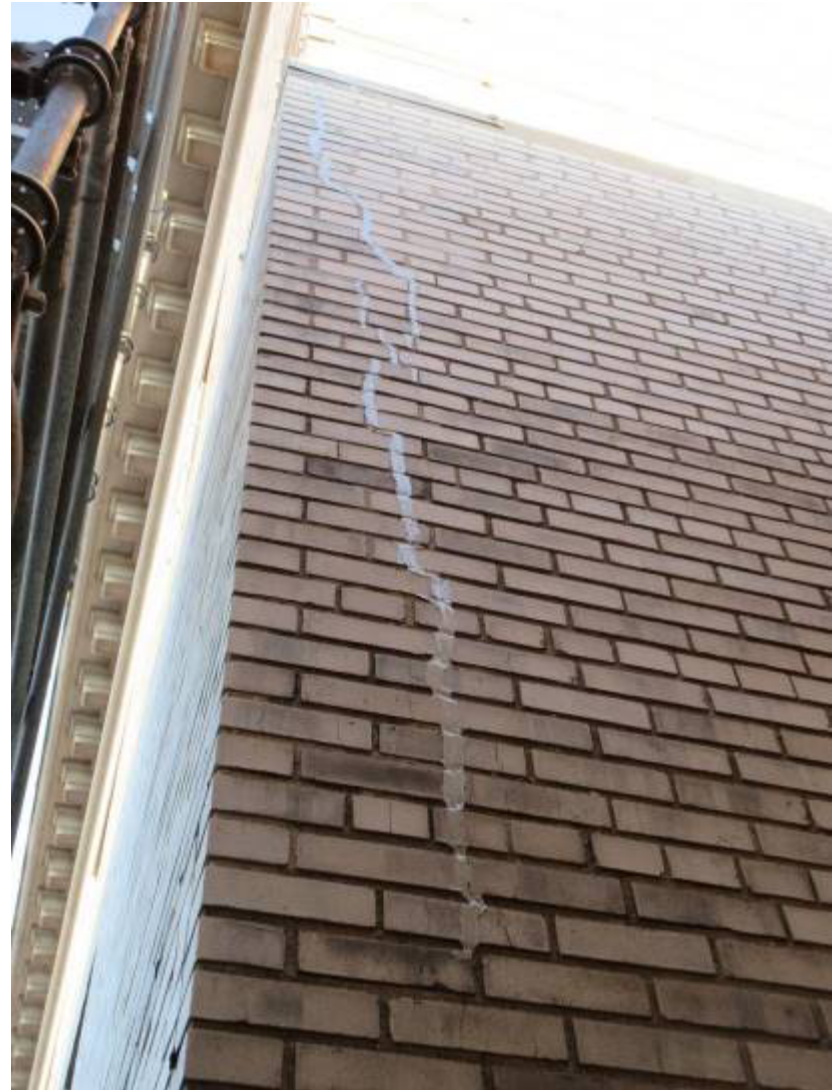
Photo No. 48 Cracked brickwork at the 6th floor level, Drop no. 21, was sealed during inspections.

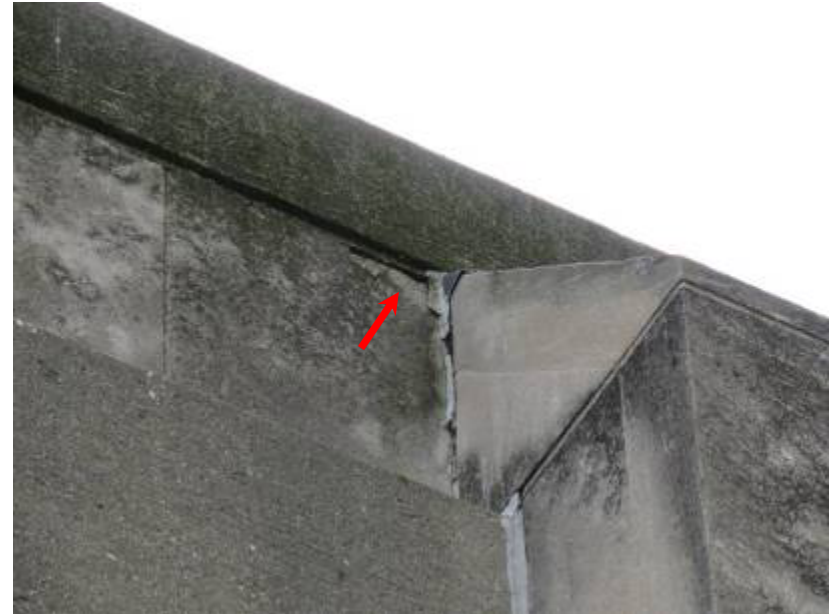
Photo No. 50 Small spall at sixth floor southeast parapet.
